# Bank On It

Earthen dam rehabilitation with geotextile fabric prevents water loss

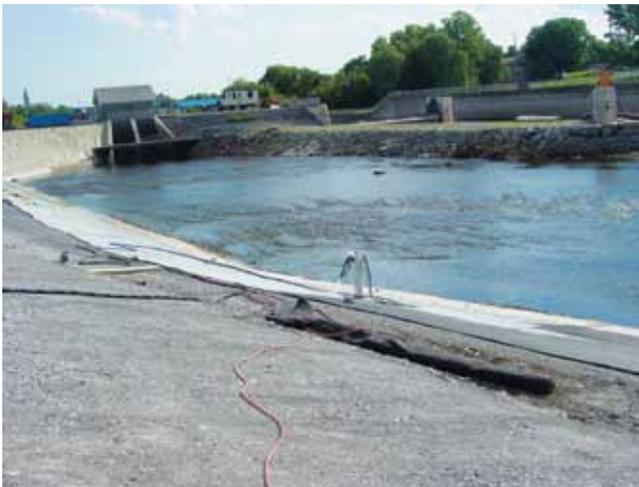
The McLeod Dam in Ontario, Canada, is a hydropower facility that powers the equivalent of 400 homes.

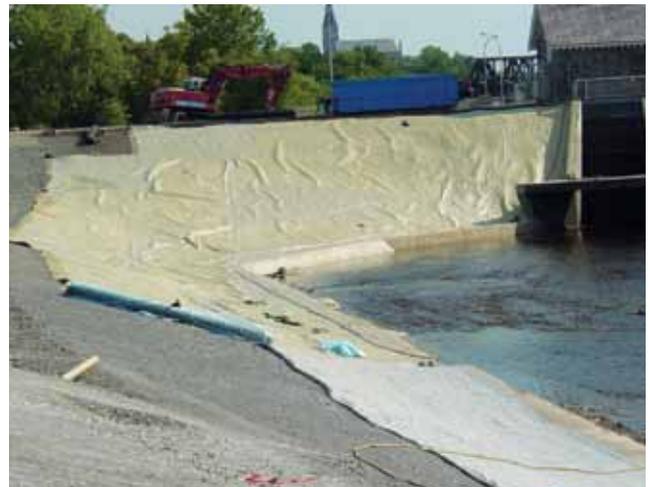
As the hydropower facility was being constructed, a leak in the dam embankment was discovered.

During construction of the hydropower facility, Quinte Conservation discovered leakage through the dam embankment. Over the years, the PVC liner along the floodwall continued to decay. This damage allowed water permeation through the liner, which contributed to a loss of water flow through the hydropower turbines and a higher-than-normal water table in the surrounding area.

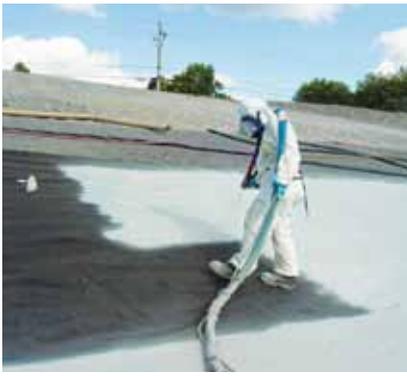
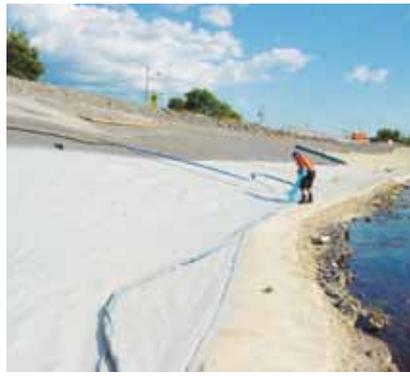
Engineers dewatered the reservoir and installed a seamless spray-on polyurea liner over geotextile fabric to create a watertight membrane.

The sheets of geotextile were rolled out, seamed and attached at the top and bottom of the embankment. Then the fabric was sprayed with Rhino Extreme 11-55 at a thickness of 80 to 100 mils. Gravel and riprap were layered over the

polyurea-coated geotextile to protect it from ultraviolet degradation and preserve the look of a natural riverbed.
